OPERATION REDWING - PROJECT 5.9

WEAPON EFFECTS ON MISSILE STRUCTURES AND MATERIALS (U) SANITIZED VERSION

C. J. Cosenza, Lt, USAF, Project Officer
G. W. Mills
G. J. Roth

Aircraft Laboratory
Wright Air Development Center
Wright-Patterson Air Force Base
Dayton, Ohio

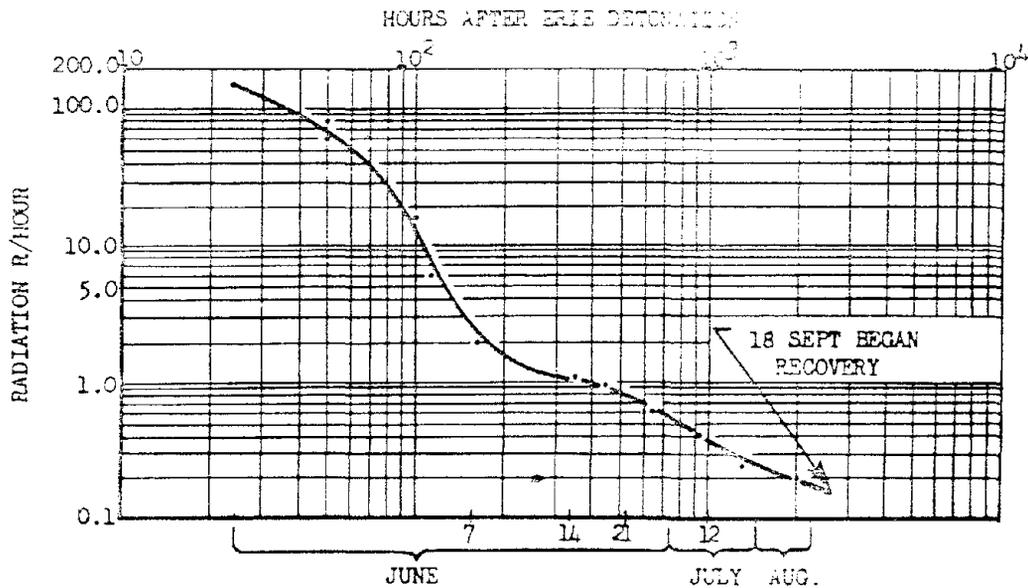
Figure 3.2 Radiation decay of Site Yvonne.

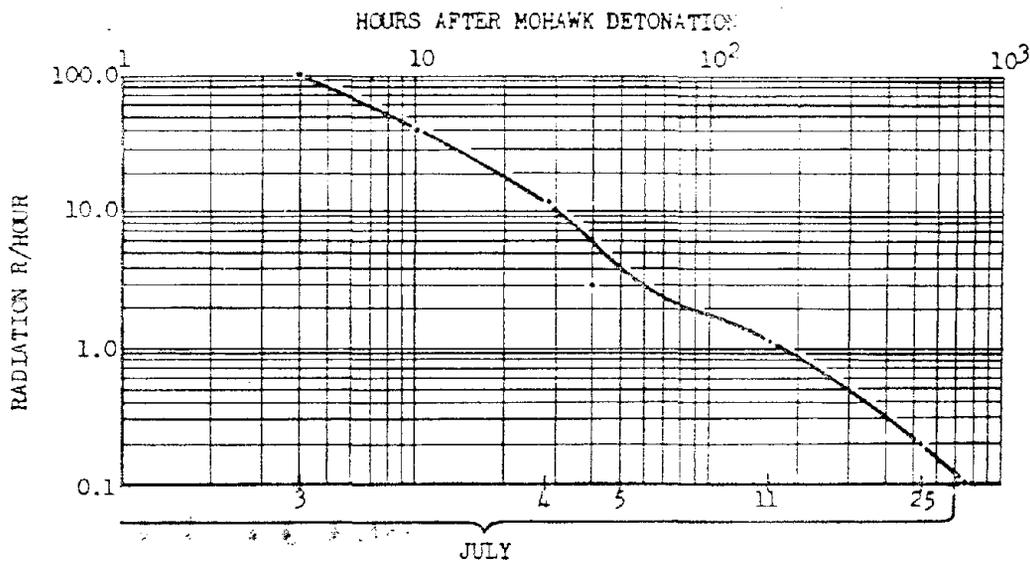
Figure 3.3 Radiation decay of Site Sally.

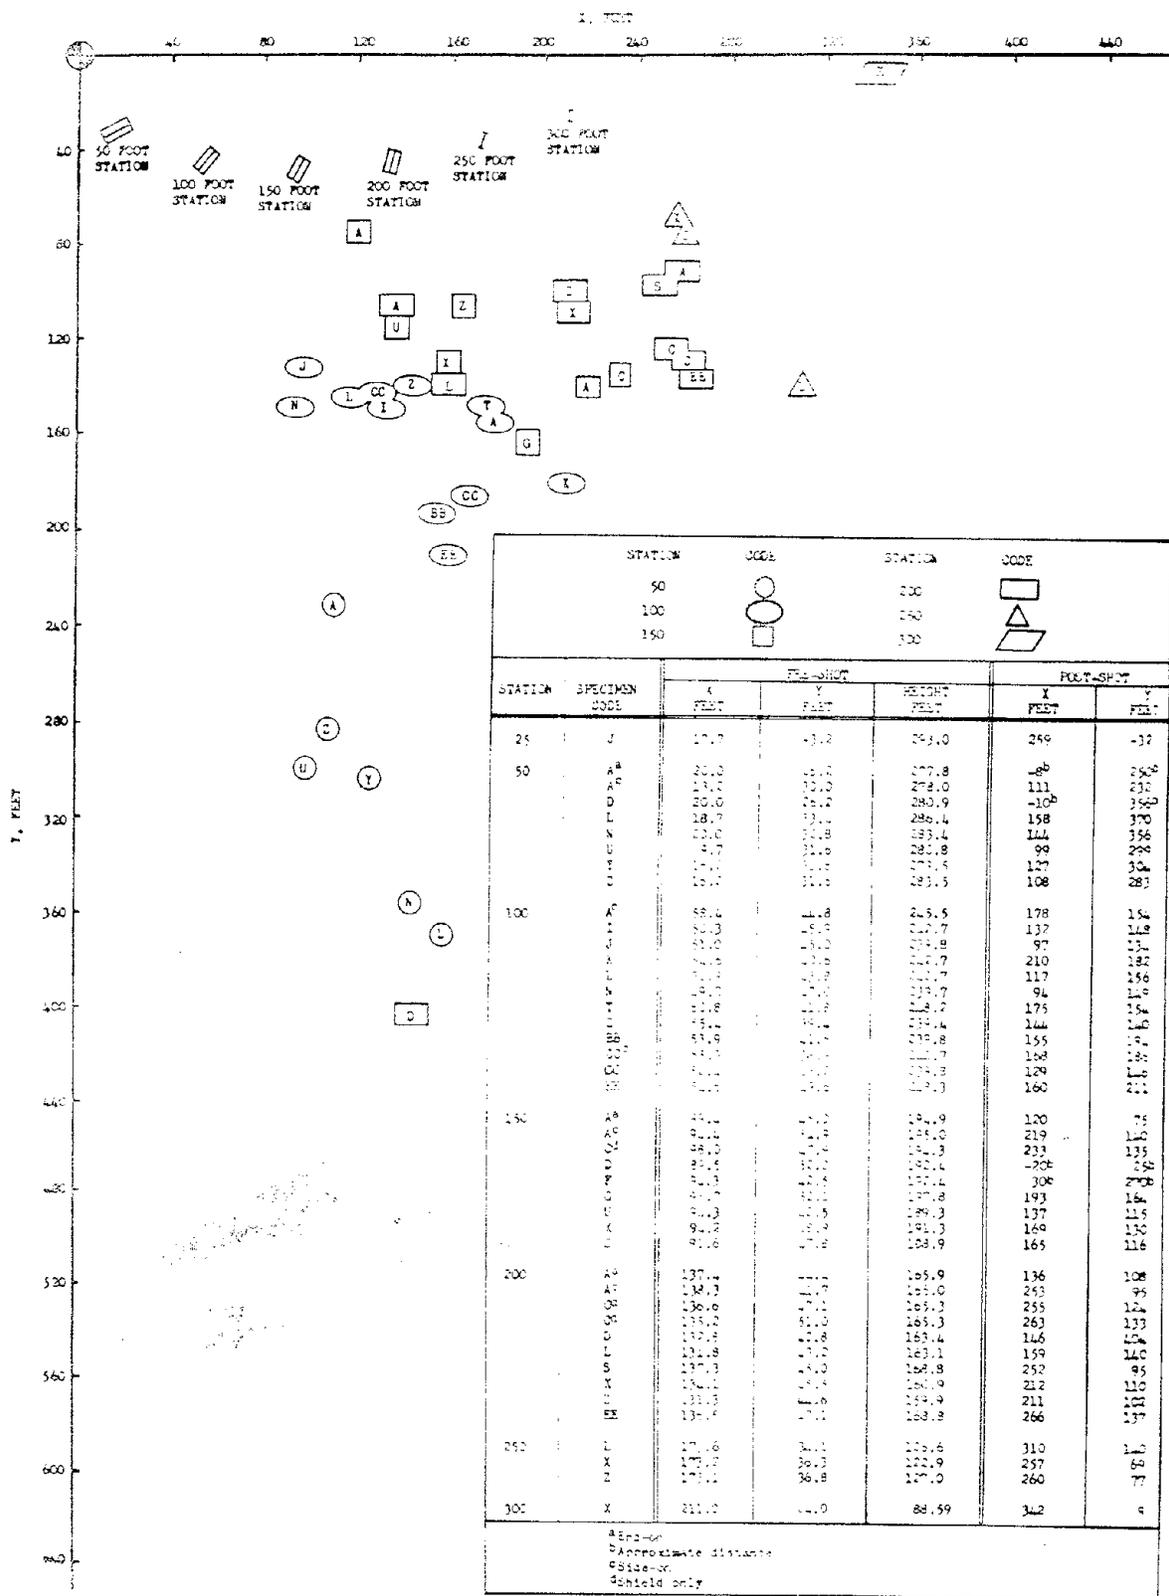
Figure 3.5 Recovery locations with a table of pre-shot and post-shot coordinates of those specimens which were found in the impact area, Shot Erie.

3.1.3 Recovered Specimens Summary. Table 3.1 lists the specimens, or parts of specimens, recovered from Shot Erie. Forty-four of these specimens were recovered in their impact locations, and the remainder were found in the dumping area. Figure 3.5 shows the recovery locations of the majority of these 44 specimens with respect to their original positions and the burst point. A table listing the preshot and postshot coordinates of each specimen found in the impact area is also included in Figure 3.5.

3.2.6 Ballistic and Dynamic-Pressure Cylinders. All the ballistic and dynamic-pressure cylinders were recovered. The recovery locations of the ballistic cylinders are shown in Figure 3.5. It may be noted that the two cylinders which were side-on, one Type BB and one Type CC, were found at approximately the same distance from their original position and that the one which was end-on did not travel as far. The side-on cylinder with the plastic disk (CC) was found at a range of 185 feet, the one without the plastic (BB) was found at 184 feet, and the end-on cylinder (CC) was found at 129 feet.

Recovery locations of those specimens found in their original impact points are shown in Figure 3.5.

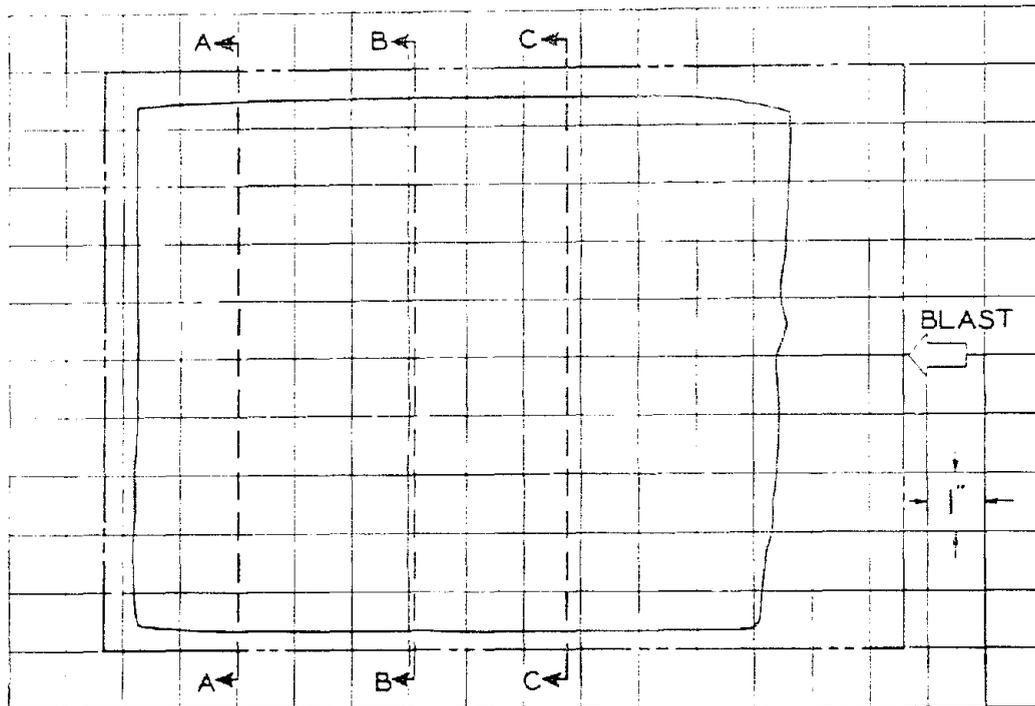
Figure 3.11 Flar plate grooved longitudinally, 150-foot station, Shot Erie.

The longitudinally grooved plate recovered from the 150-foot station showed more metal loss toward the front than it did toward the rear on both the grooved and flat sides. The grooved side averaged between 10 and 25 percent more metal loss on the front than on the rear, and the variation along the flat side was approximately 10 percent.

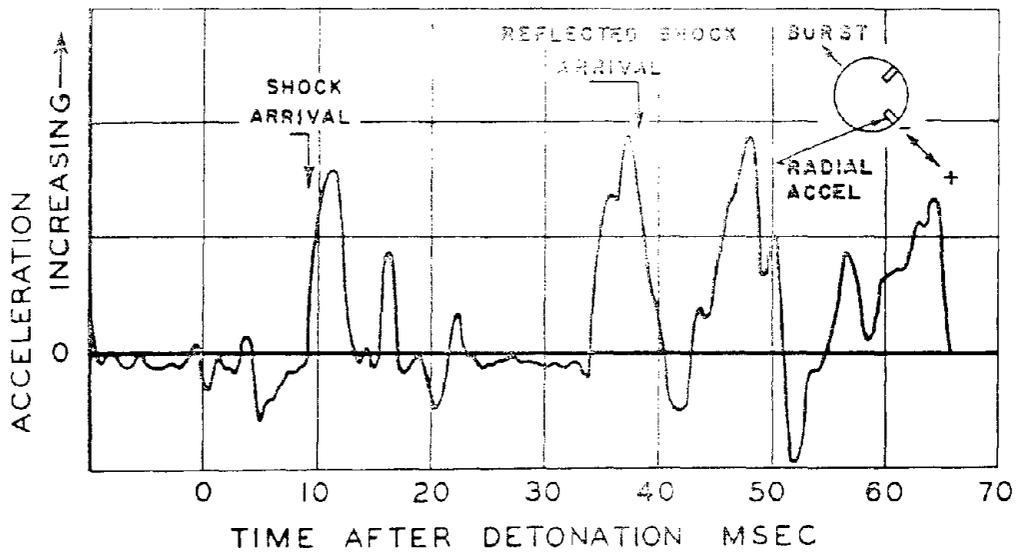
Figure 3.14 Radial acceleration versus time of instrumented sphere at Station 250.

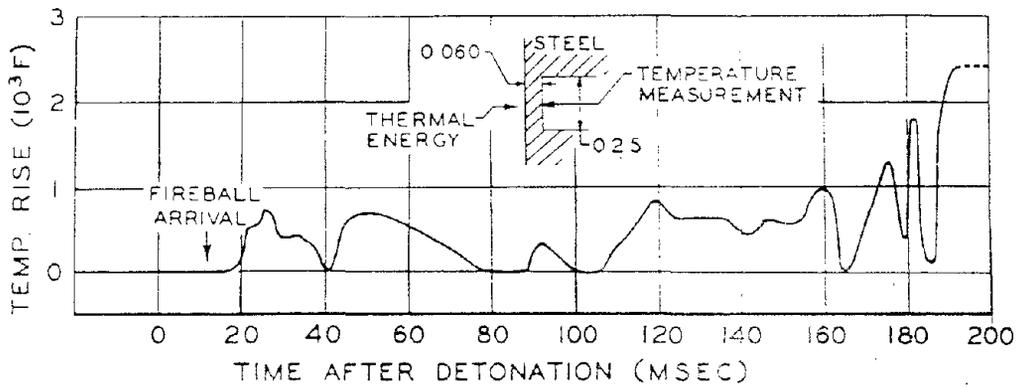
Figure 3.18 Temperature rise of steel versus time at a depth of 0.060 inch below surface of the instrumented sphere at Station 250.

Temperature of Steel at a Depth of 0.060 Inch. Figure 3.18 shows the recorded temperature time history of the rear surface of a steel diaphragm 0.060 inch thick

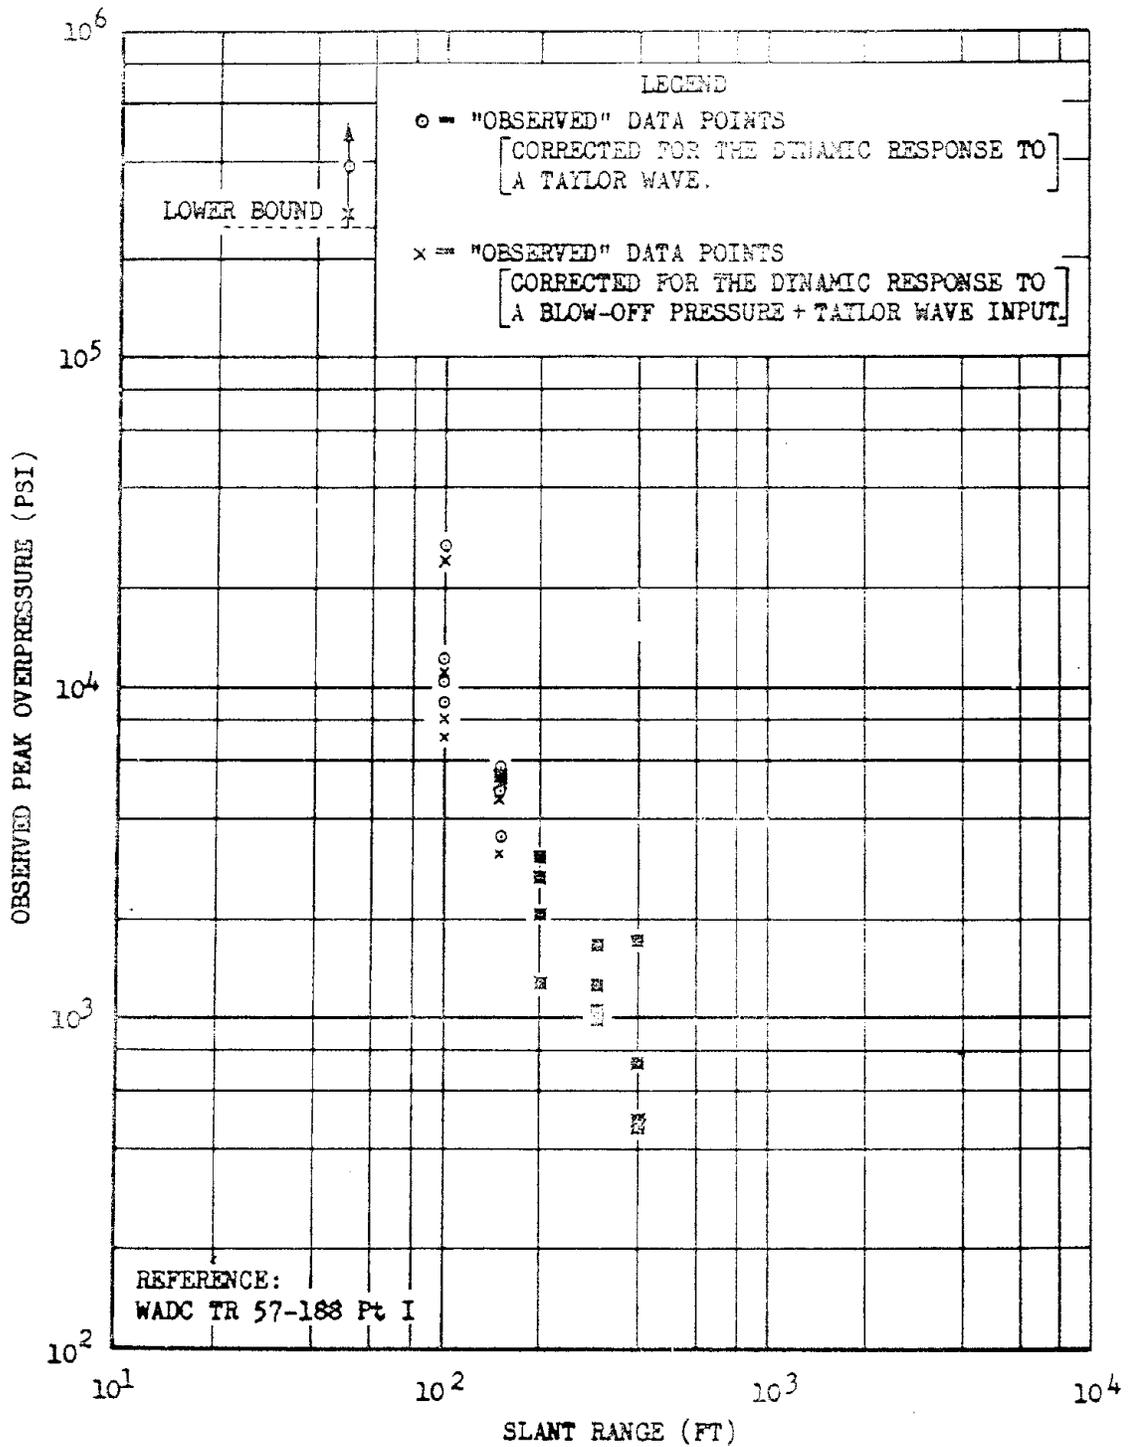
Figure 3.29 Observed peak pressures from ball-crusher gages at various slant ranges, Shot Erie.

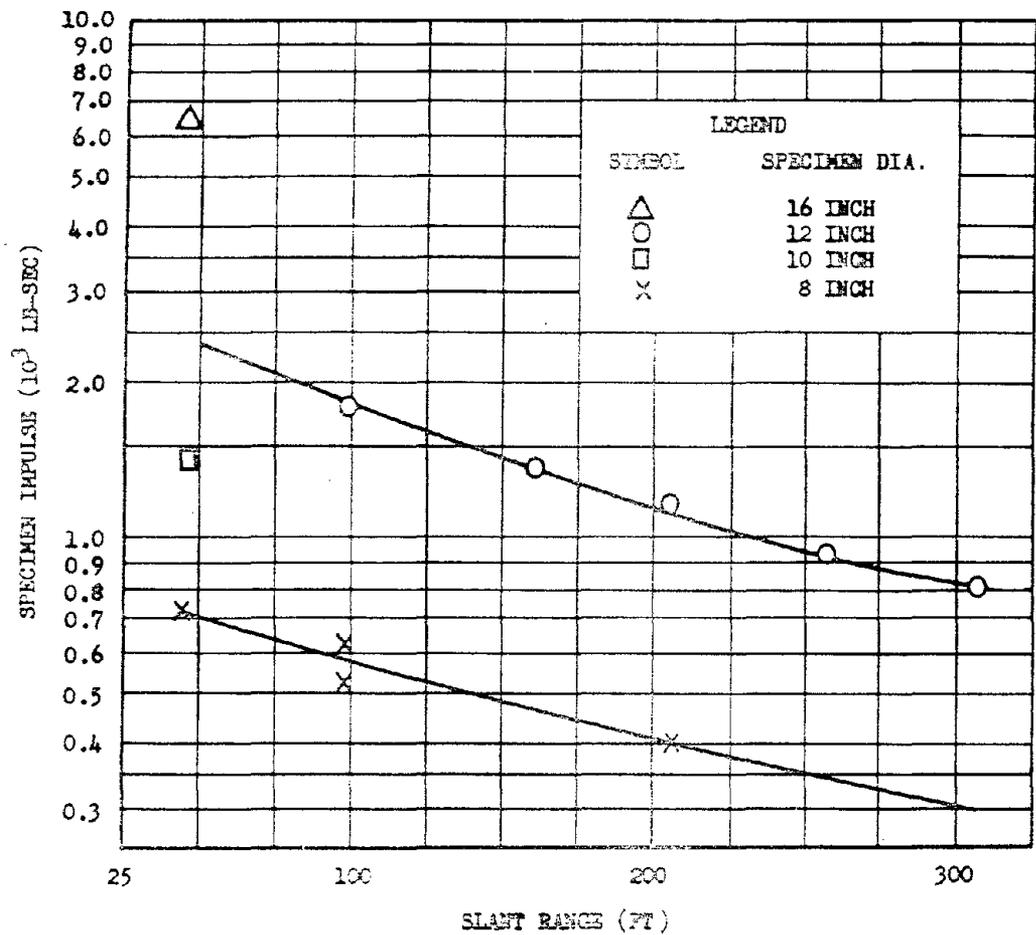
Figure 4.4 Specimen impulse as a function of slant range, Shot Erie.

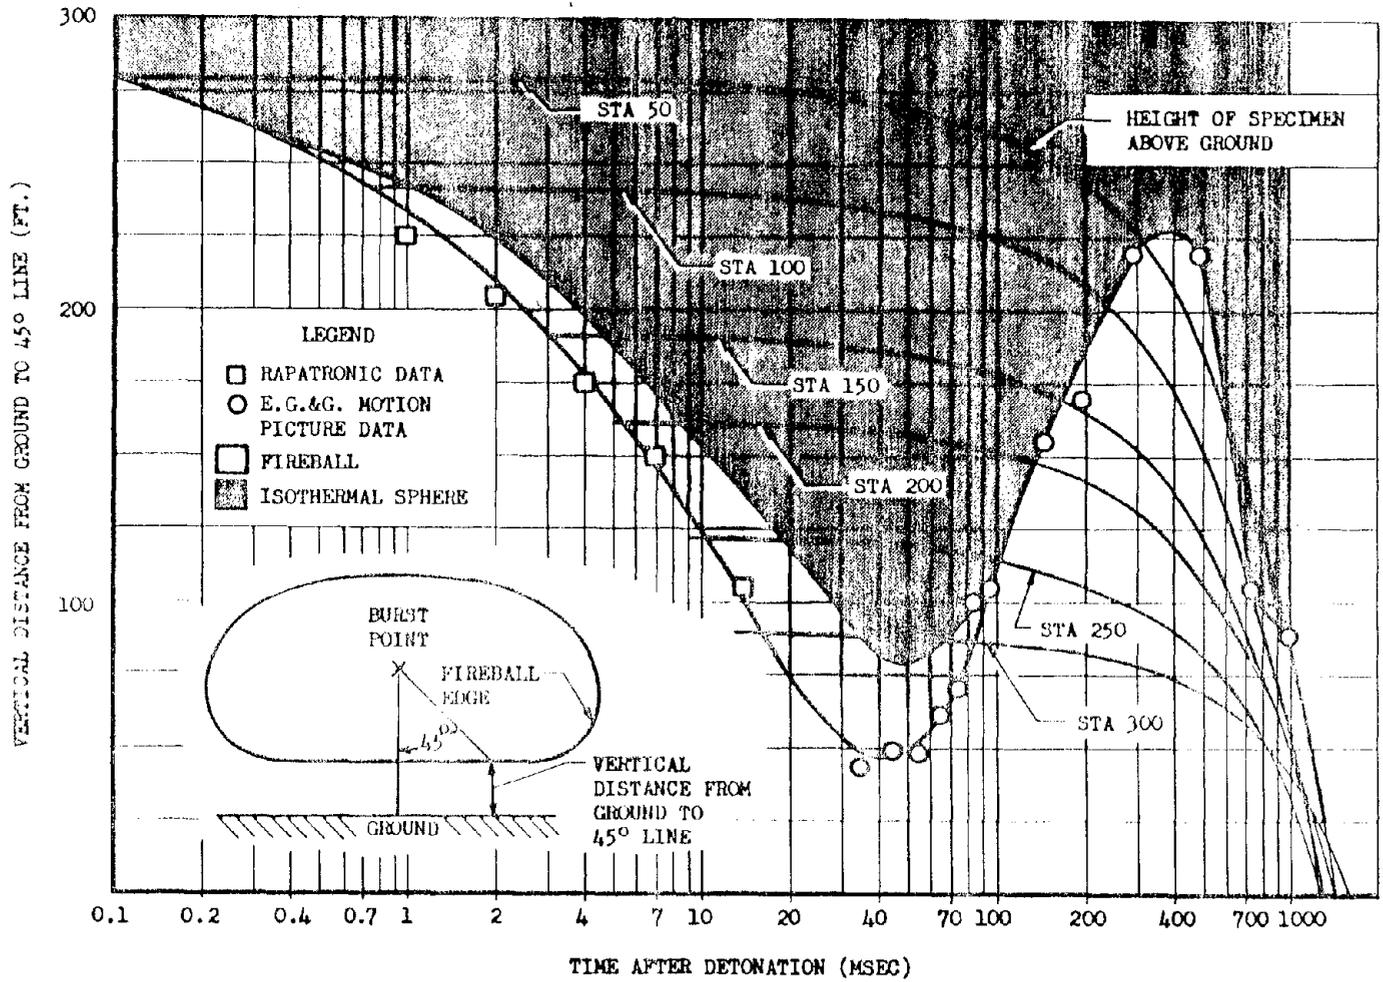
Figure 4.5 Engulfment time determination for the electrically instrumented specimens.

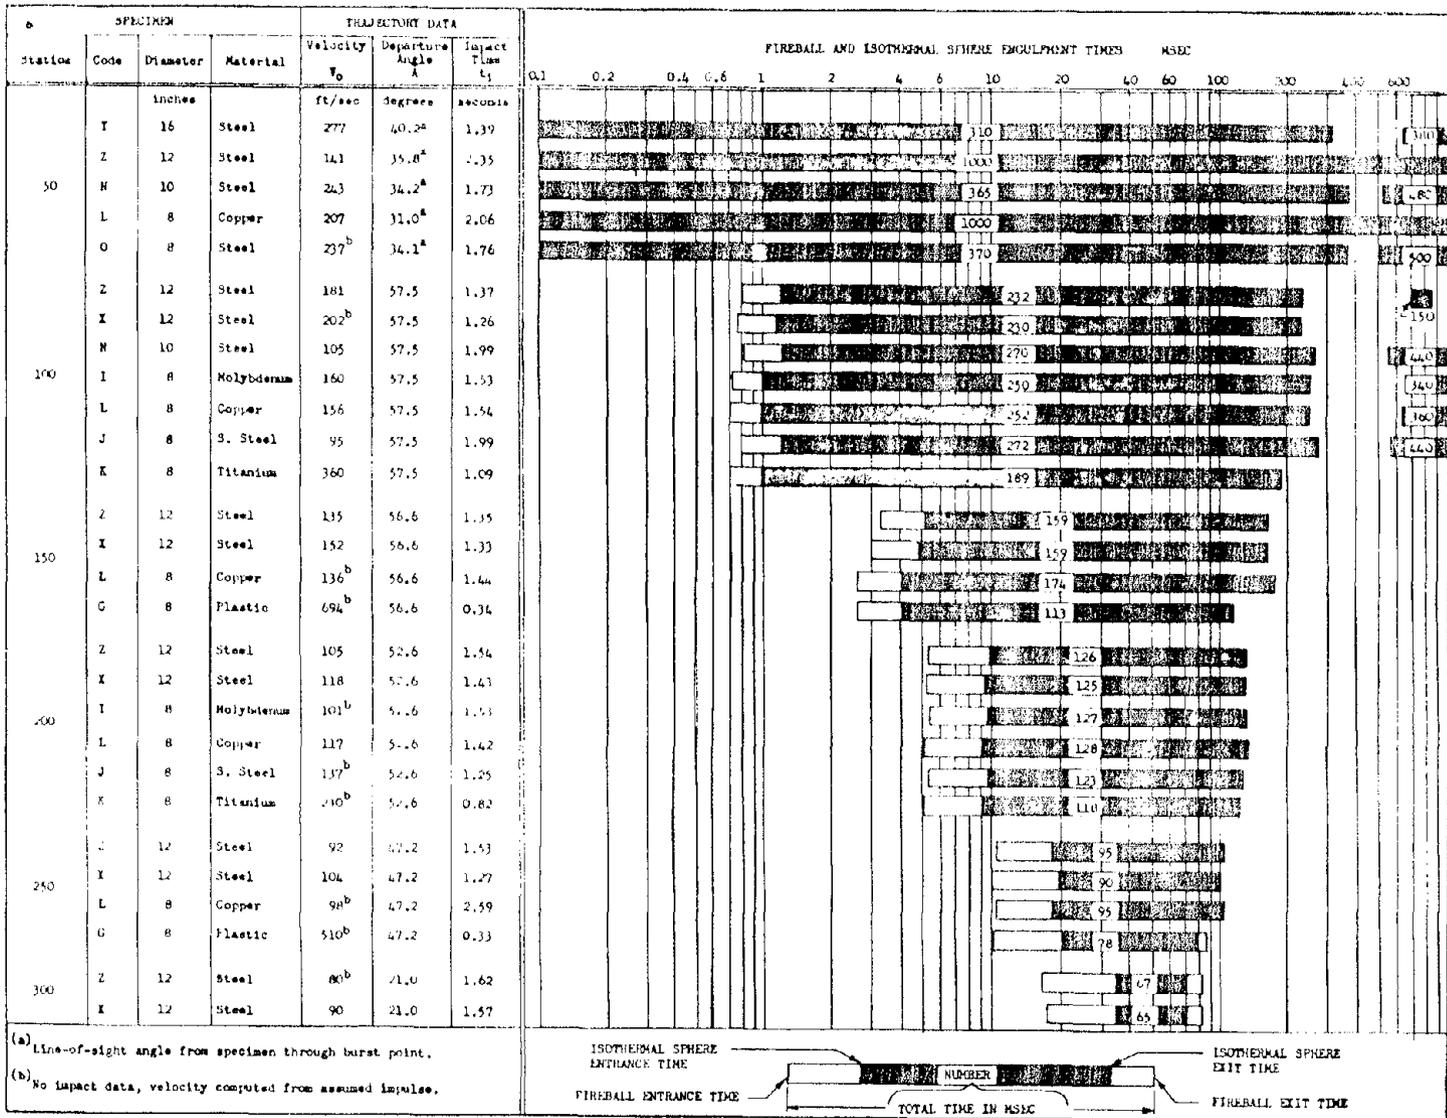
Figure 4.6 Engulfment times for Shot Erie spherical specimens.

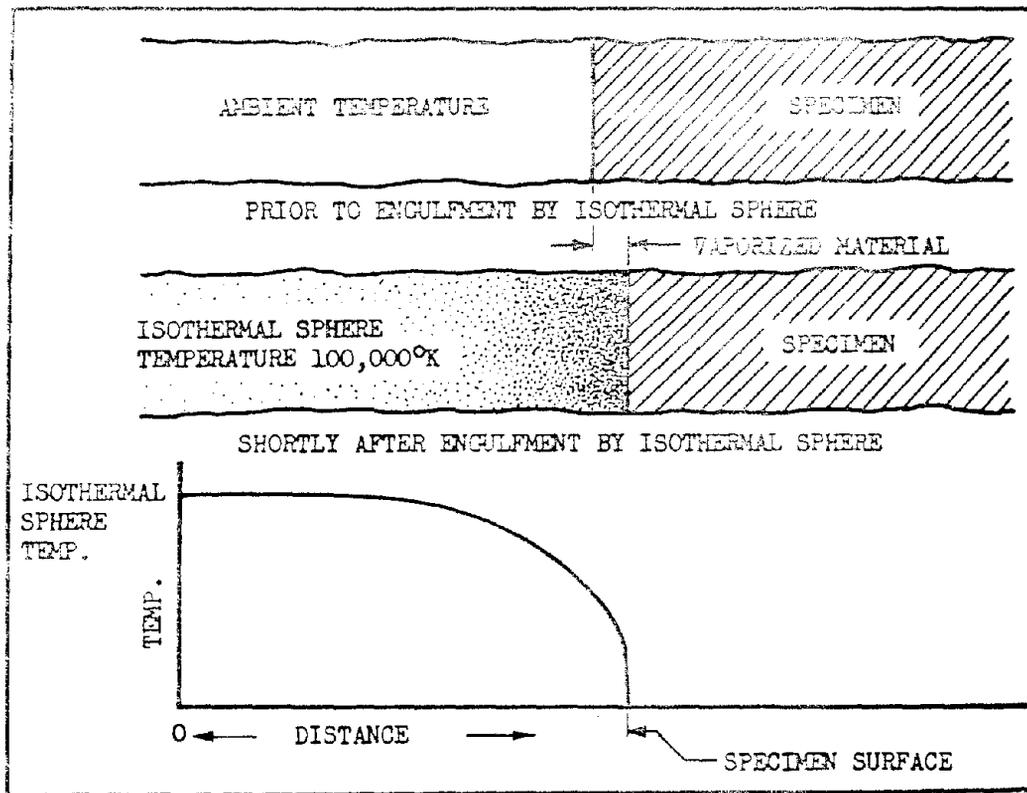
Figure 4.7 Vapor layer attenuation.

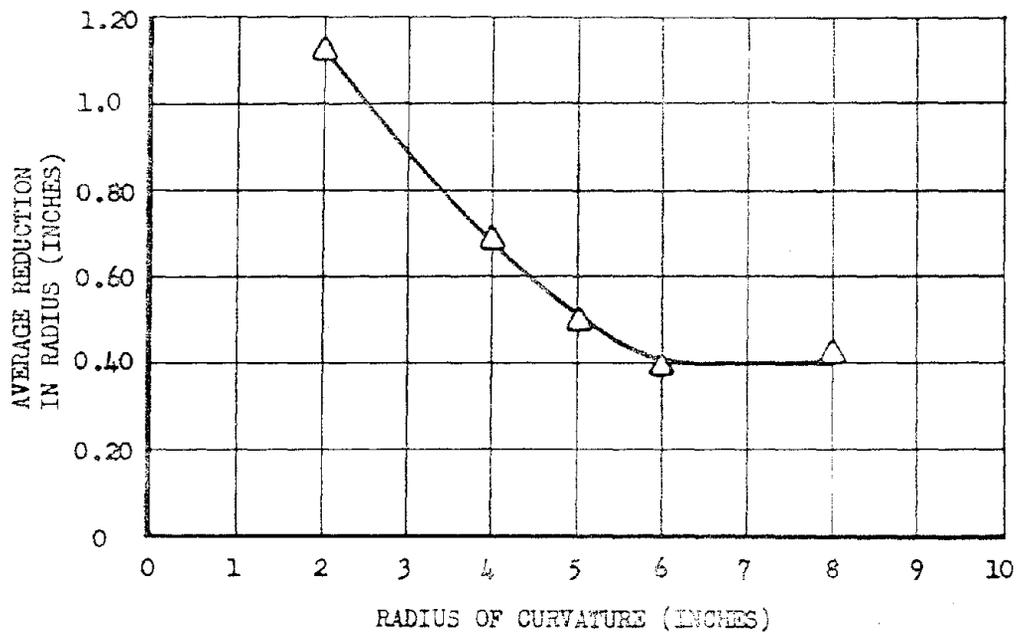
Figure 4.8 Radius of curvature effect for spherical specimens at the 50-foot station, Shot Erie.

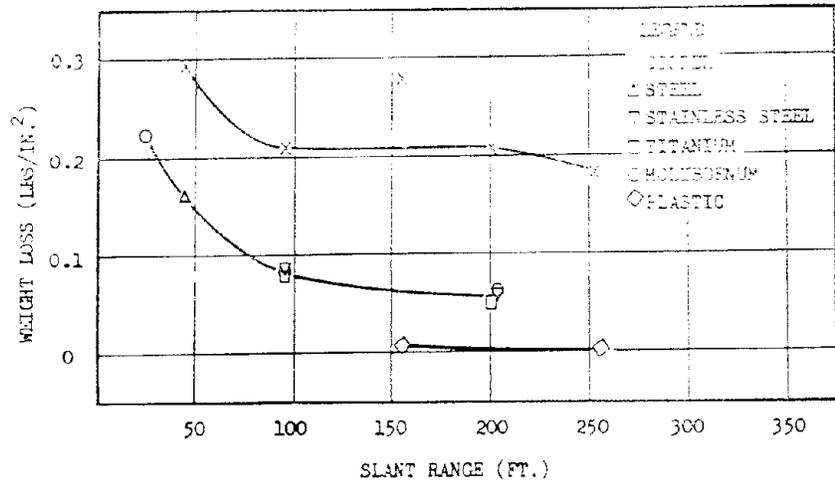
Figure 4.12 Ablation of 8-inch-diameter spheres as a function of slant range for Shot Erie.

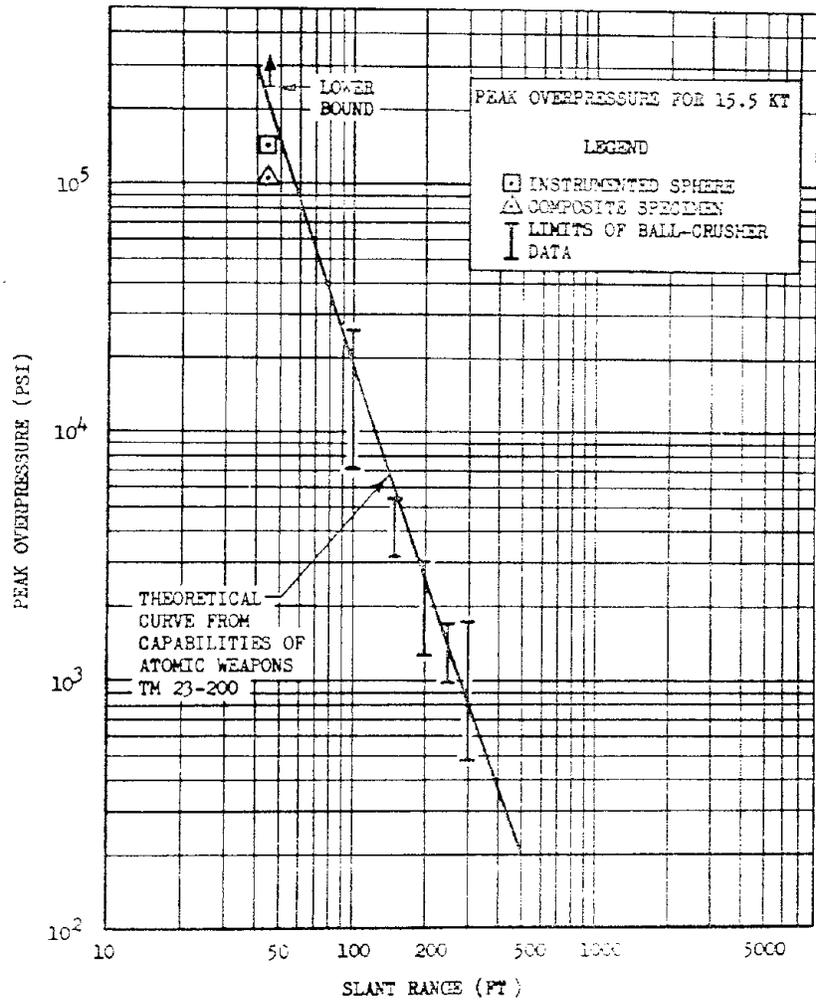
Figure 4.13 Overpressure as a function of slant range for Shot Erie.

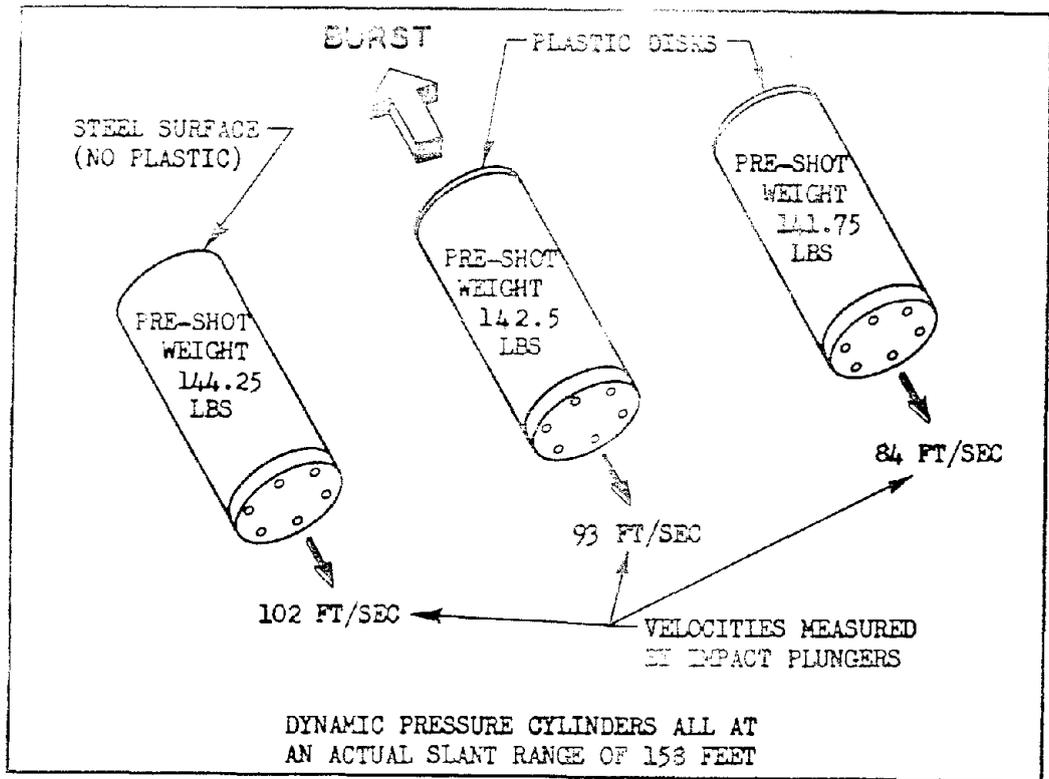
Figure 4.14 Weights and velocities of dynamic pressure cylinders at Station 150.

Three end-on dynamic-pressure cylinders with the velocity distance impact gage at the 150-foot station yielded some information relative to the blow-off pressure of plastic and steel. Figure 4.14 shows the three specimens, their preshot weights, and velocities as measured by their respective velocity distance impact gages. The two specimens with the plastic disks were found in the dumping area and their impact locations are unknown. Since all three specimens were practically identical as to size, shape, and weight, except for the plastic disks on the front surface of two of them, and since they were all at the same slant range, it is possible that the difference in their velocities was due to the difference in the blow-off pressures of steel and plastic. This line of reasoning indicates that steel has a larger blow-off pressure than plastic. However, because the difference between the velocities of the two specimens with plastic is equal to the difference between the all-steel specimen and the high velocity plastic disk specimen, the basis for this conclusion may be the normal errors associated with data of this type.

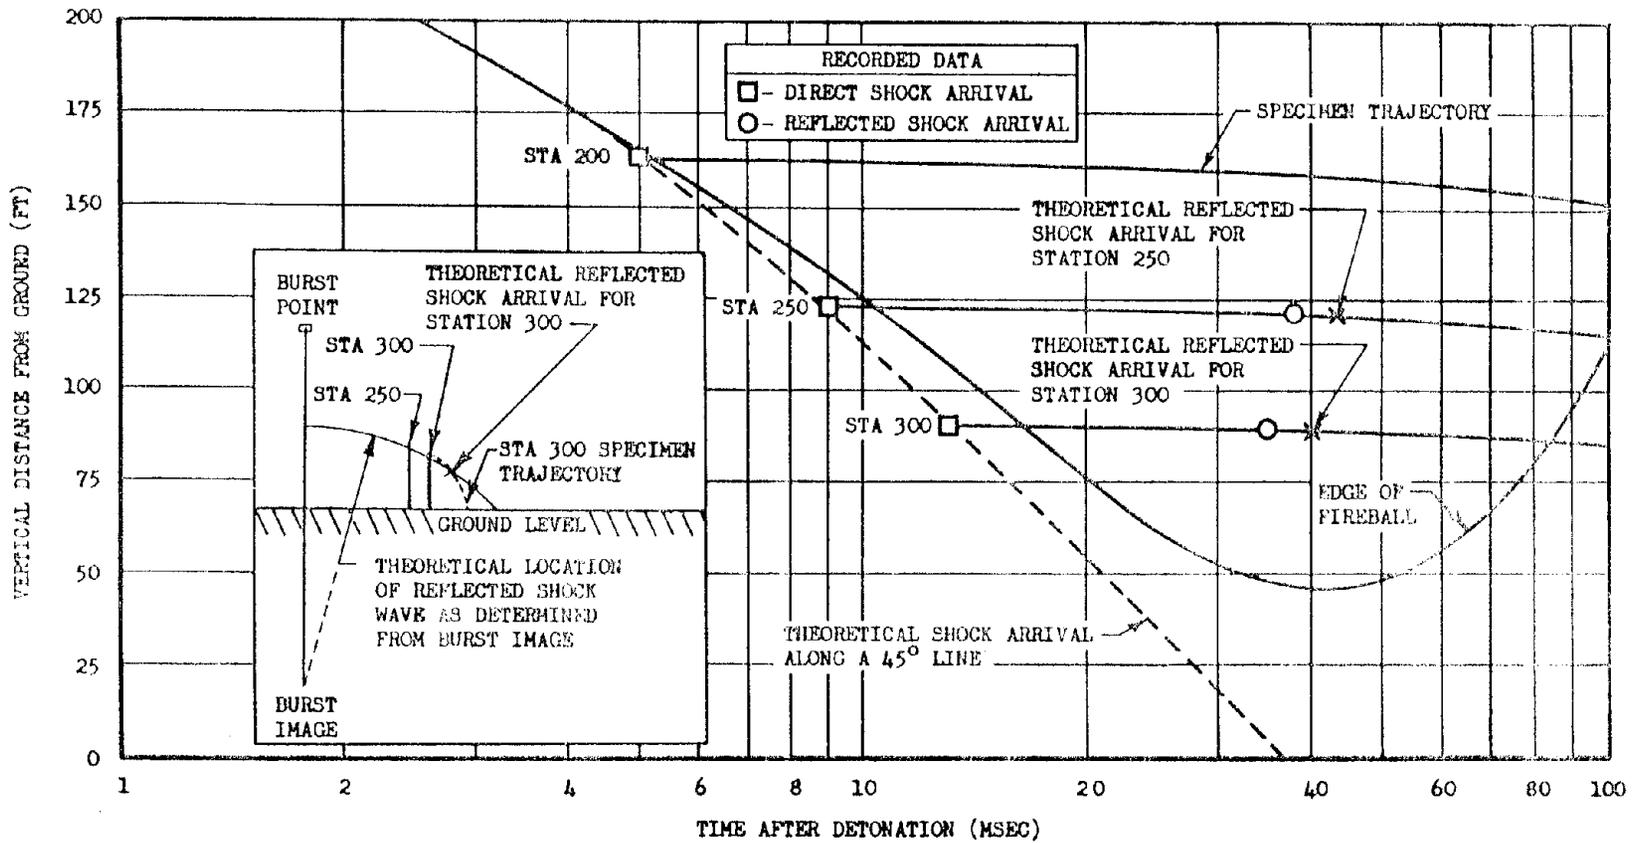
Figure 4.18 Correlation of electrically recorded and theoretical shock arrival times for the Instrumented spheres at Stations 200, 250, and 300, Shot Erie.

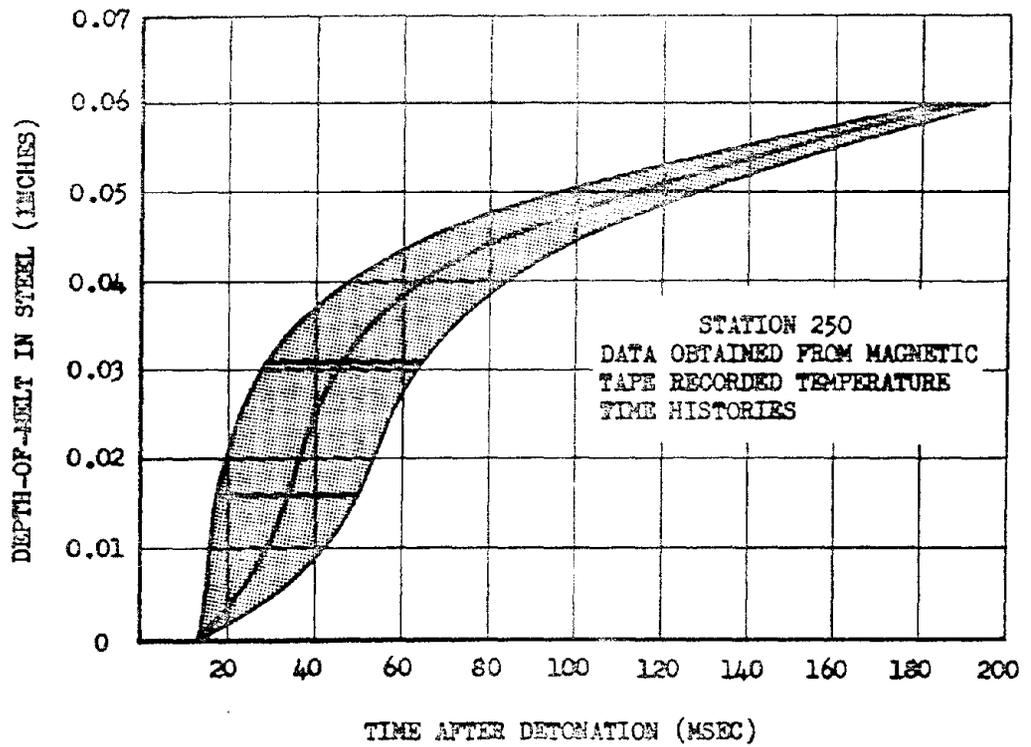
Figure 4.19 Depth of melt as a function of time for: Station 250 instrumented sphere.

The isothermal sphere exit time for the Station 250 instrumented specimen was 100 msec, and its total postshot depth of metal loss was approximately 0.155 inch. Figure 4.19 shows that at the time of exit, the specimen had melted or vaporized only to a depth of approximately 0.048 inch or approximately 30 percent of its ultimate depth of metal loss. Therefore, the remaining 70 percent material ablation must have been accomplished between isothermal sphere exit time and ground impact time. Investigation of the energy available to the specimen from the large hot fireball surrounding it during this period indicated that for most of this time sufficient energy was available to melt approximately 2 to 4 (gm cm³)/sec of steel. This rate of melting for the times involved plus the material already ablated resulted in a total depth of melt approximately that of the observed postshot depth of metal loss. Removal of this molten layer could have been accomplished by a number of methods, such as sweeping, spinning-off,

Figures 4.19 and 4.20 present Table 4.3 data in the form of depth-of-melt versus time curves for Stations 250 and 300. The possible error due to the uncertainty of the times is in-

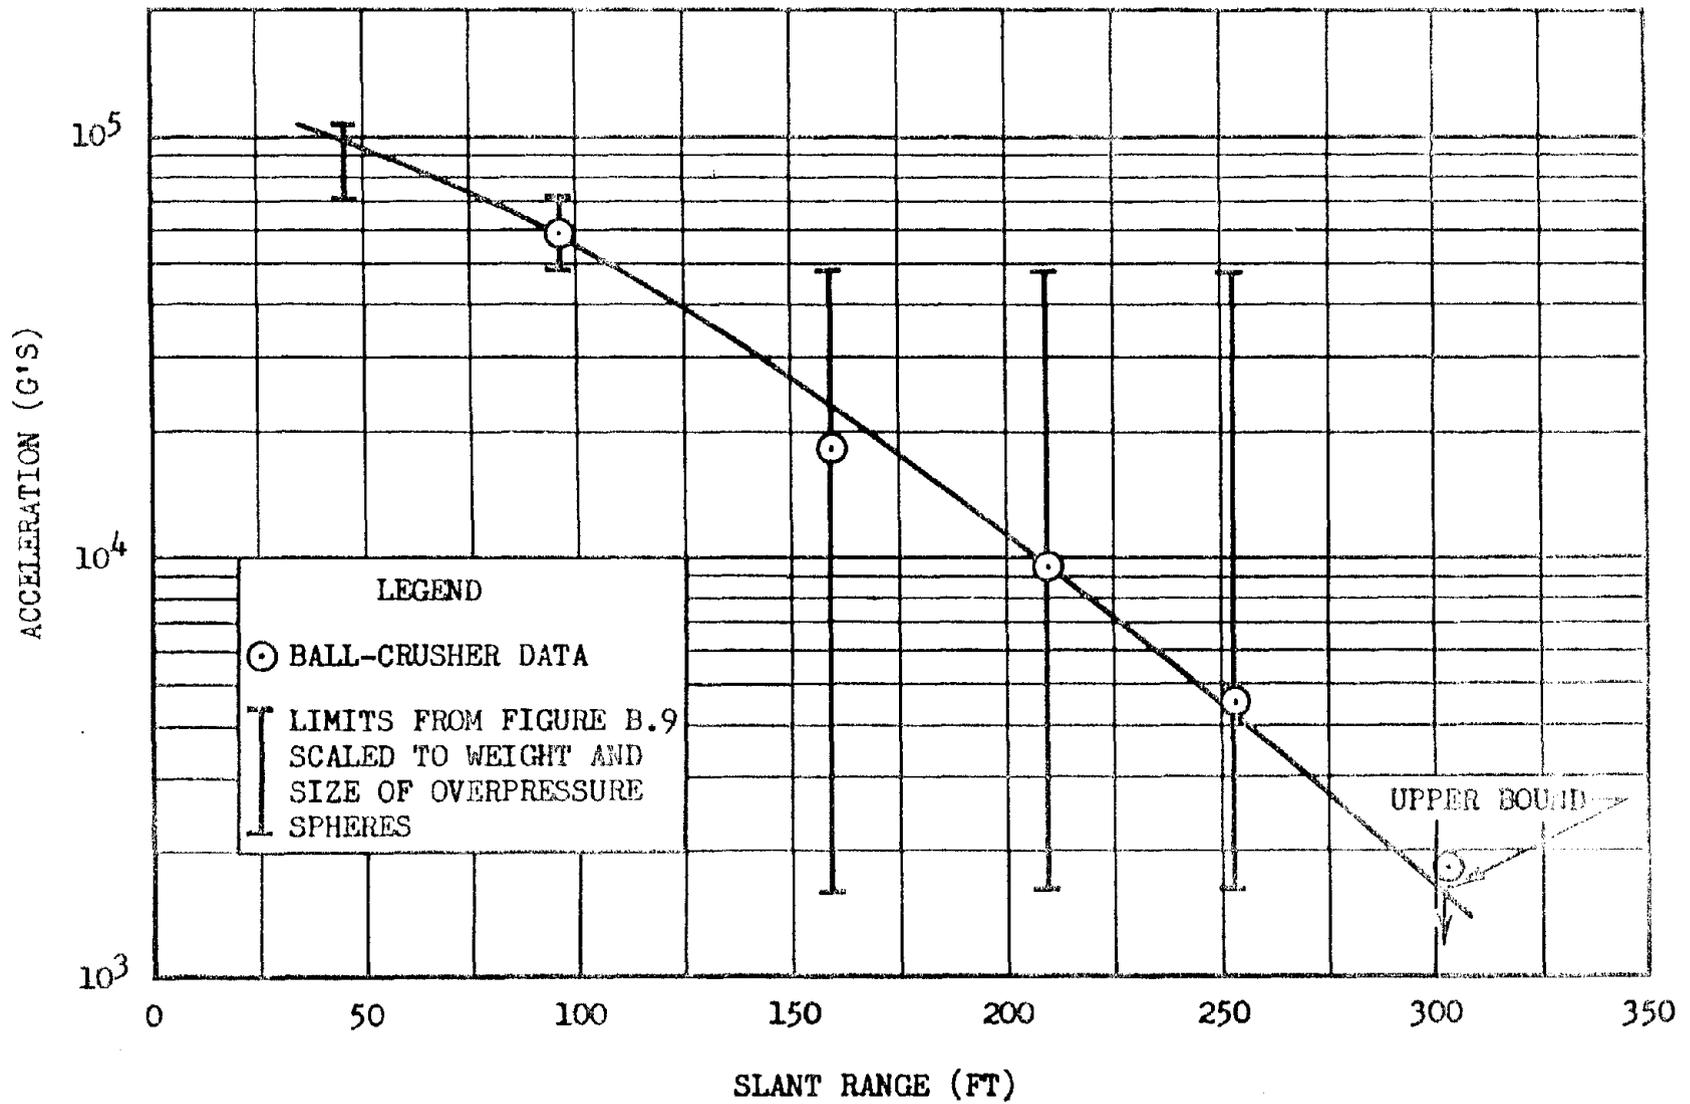
Figure 4.21 Observed peak acceleration as a function of slant range, Shot Erie.

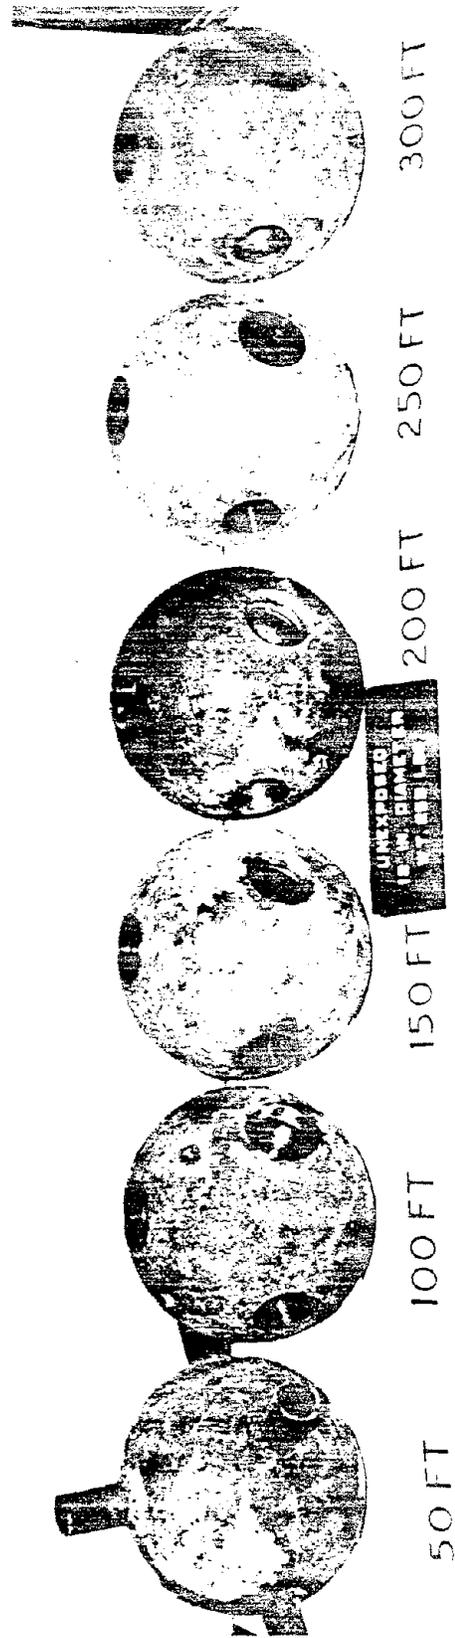
Figure A.1 Overpressure spheres with ball-crusher gages removed.

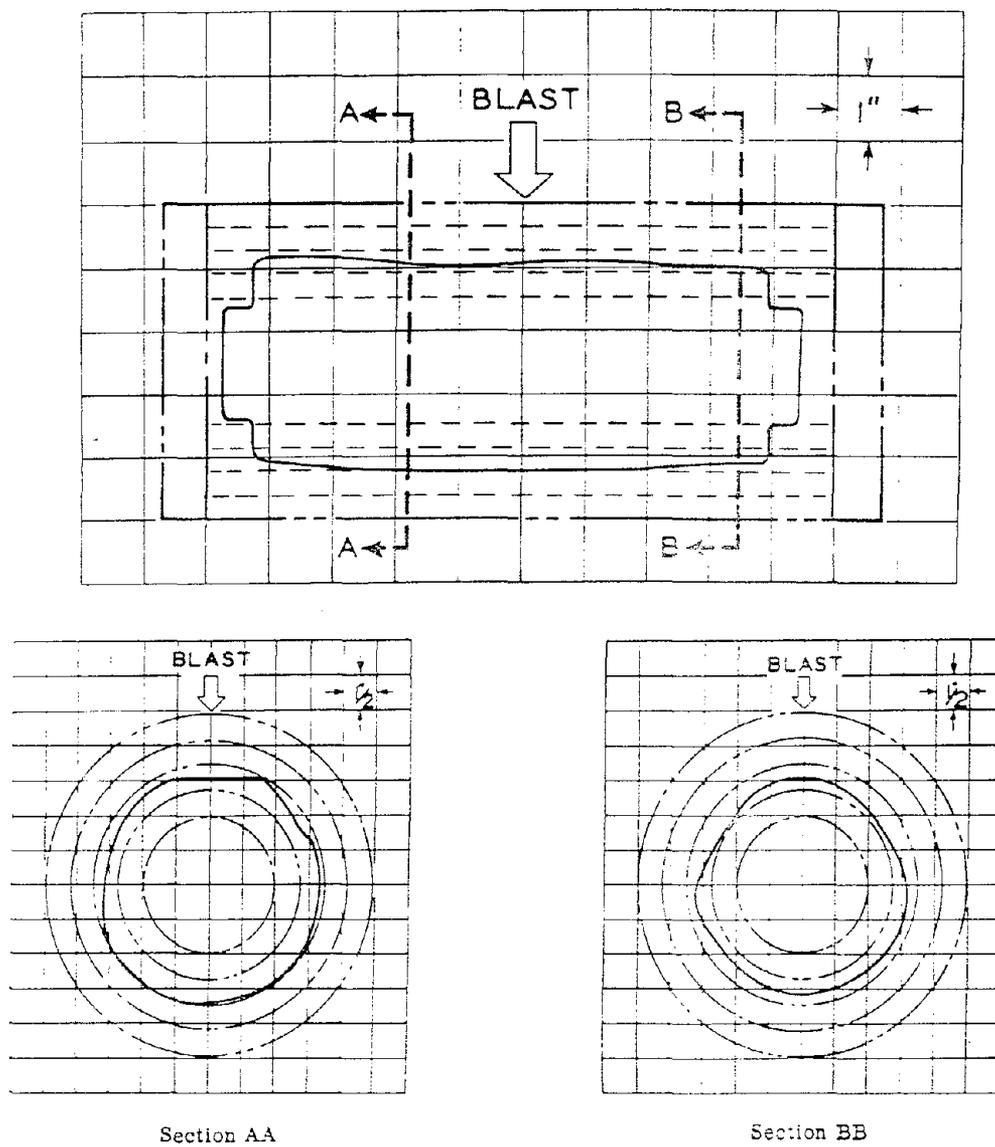
Figure A.13 Laminated cylinder, 150-foot station, four $\frac{3}{8}$ inch laminations.

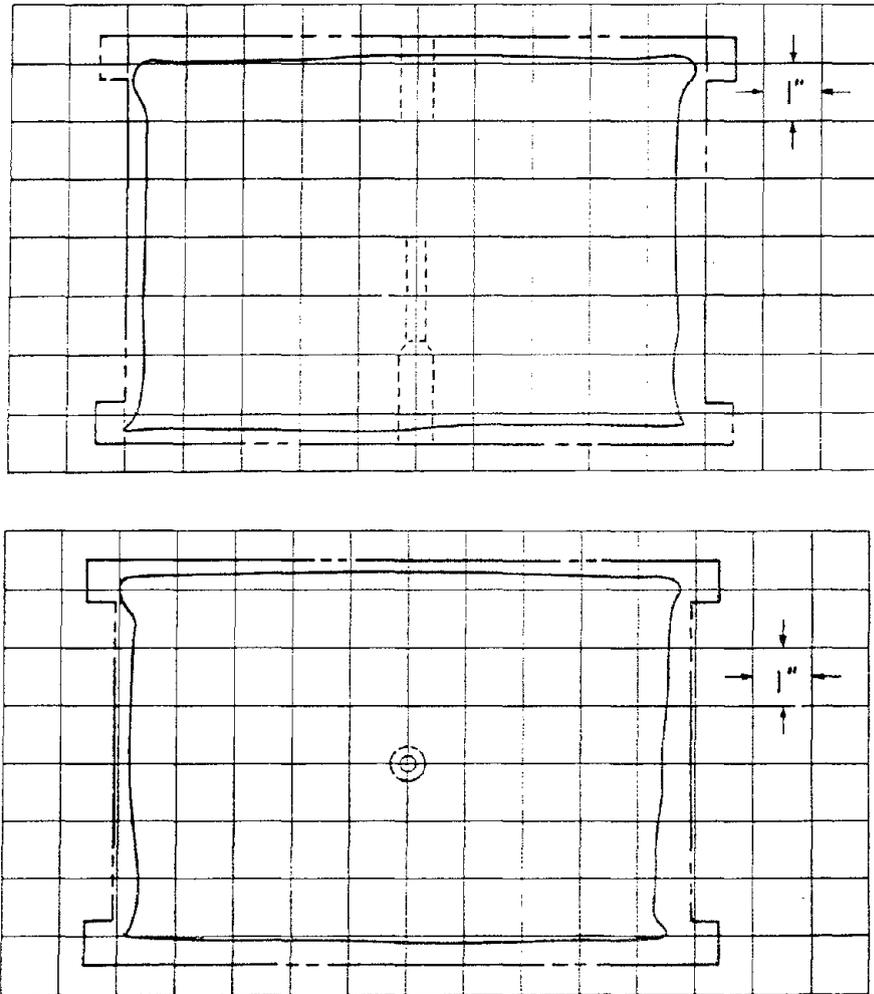
Figure A.15 Ballistic cylinder without plastic, side-on, 100-foot station.

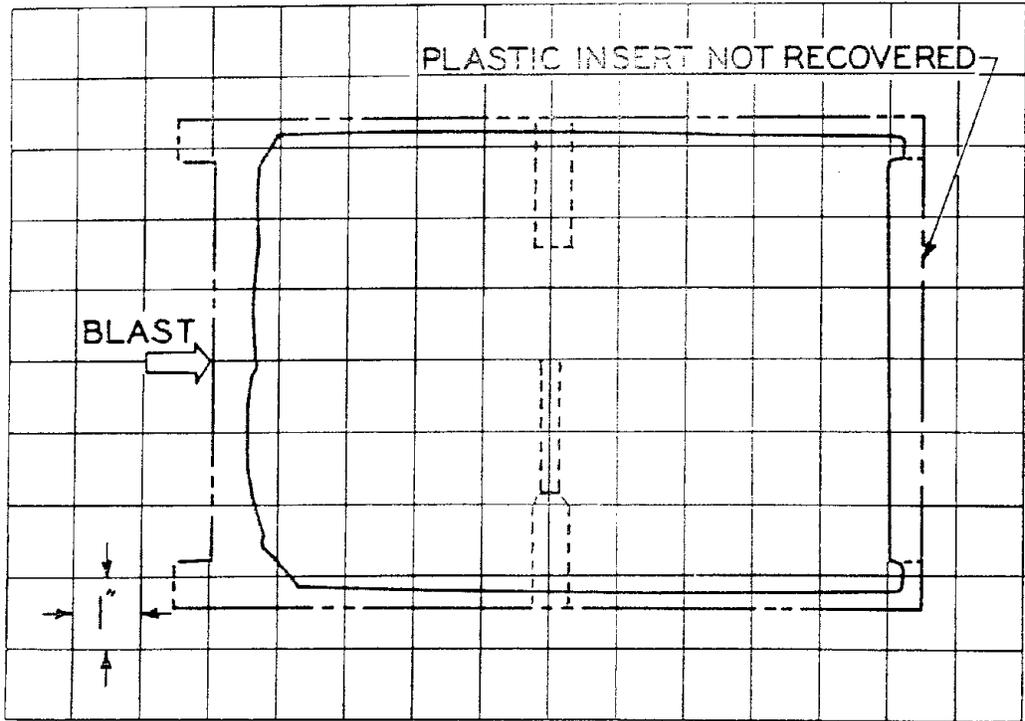
Figure A.18 Ballistic cylinder with plastic, end-on, 100-foot station.
